# THE SANITARY SURVEY REQUIRED CHANGES PER THE GROUNDWATER RULE

**September 25, 2008**

### **Maryland Department of the Environment**

**Water Supply Program**

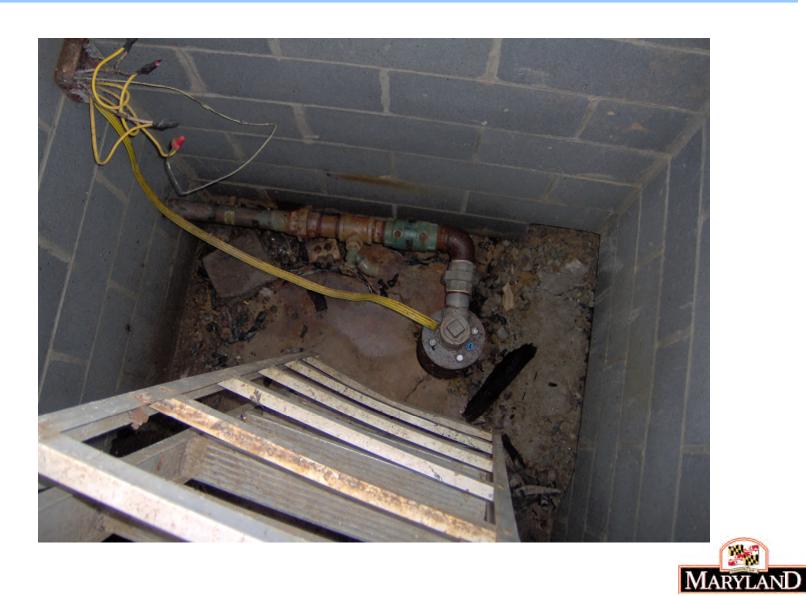
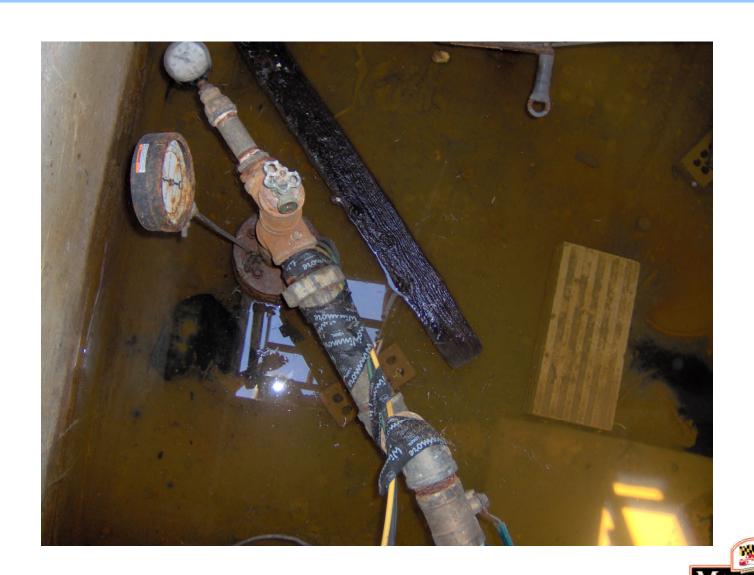
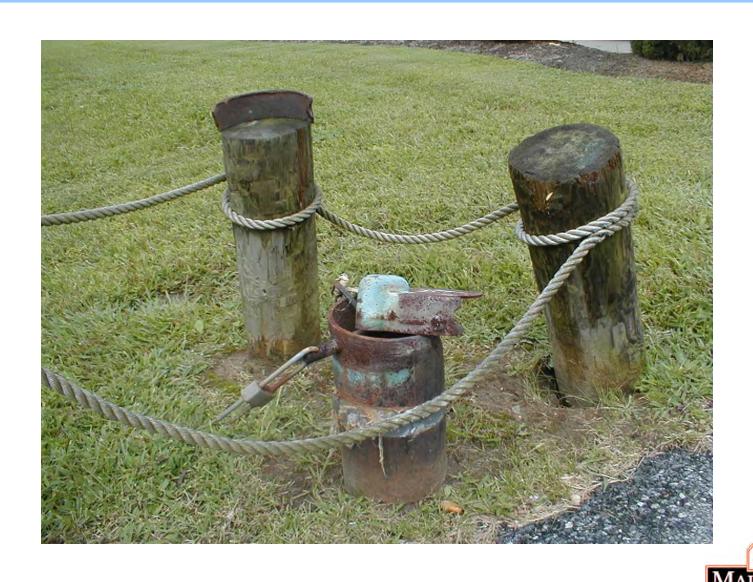
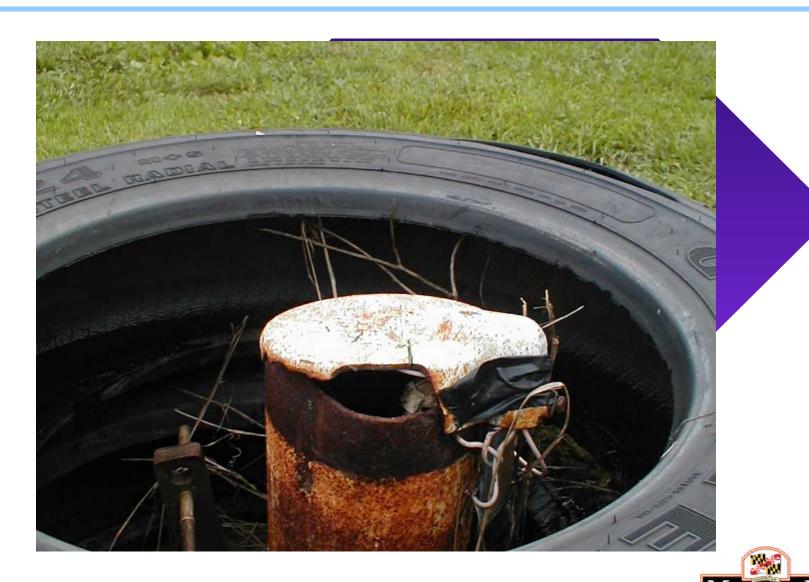
## MDE DEFECT: WELL

- Located in pit
- Cap missing
- Hole in casing or cap

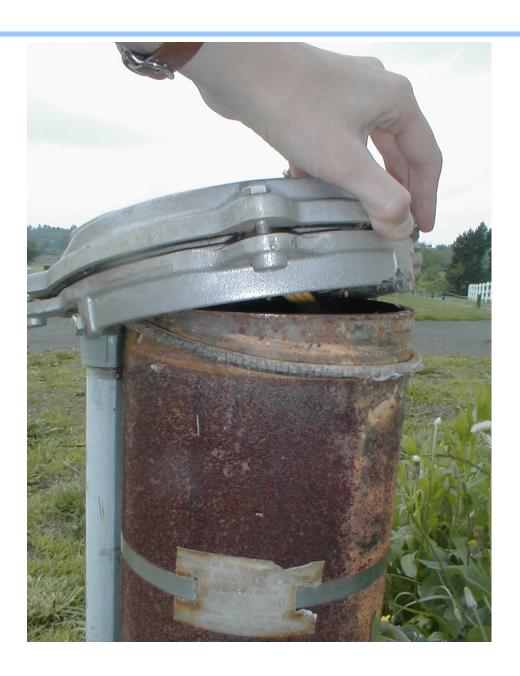
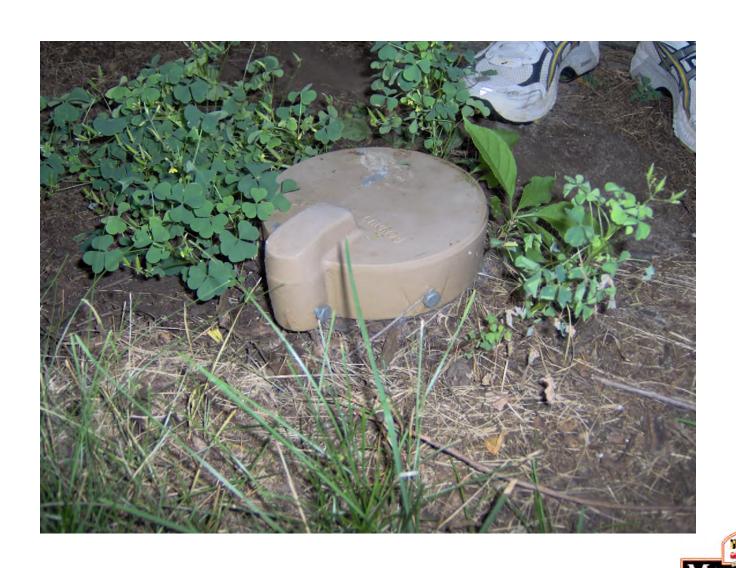
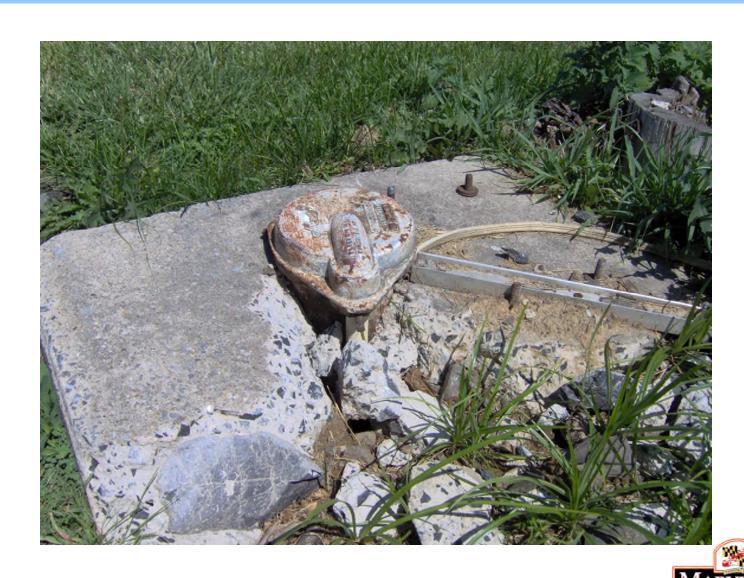
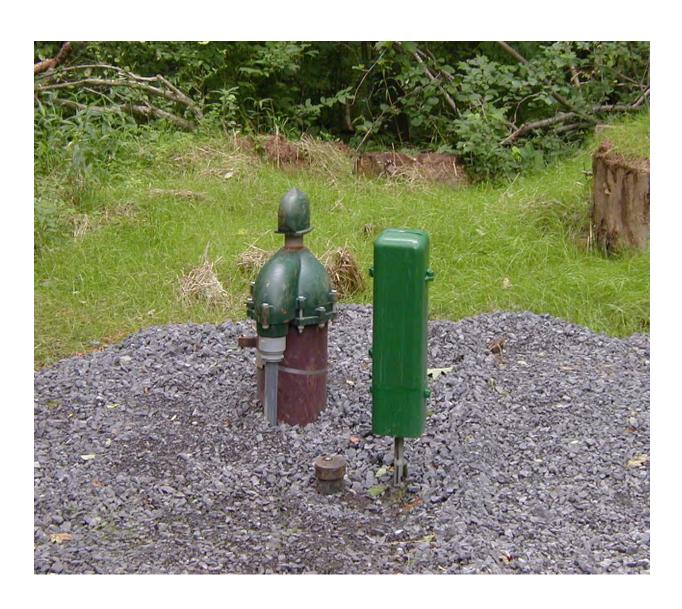
## MDE DEFECT: WELL

- Cap loose
- Hole in conduit
- Conduit not flush with cap
- Well pad damaged (esp non-grouted wells)

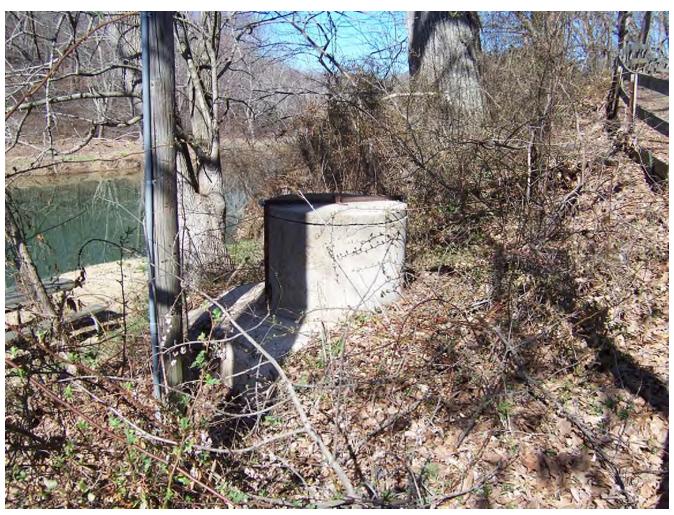
- Spring box poorly constructed
  - Surface runoff
- Spring box subject to flooding
- Look for fish, salamanders, etc

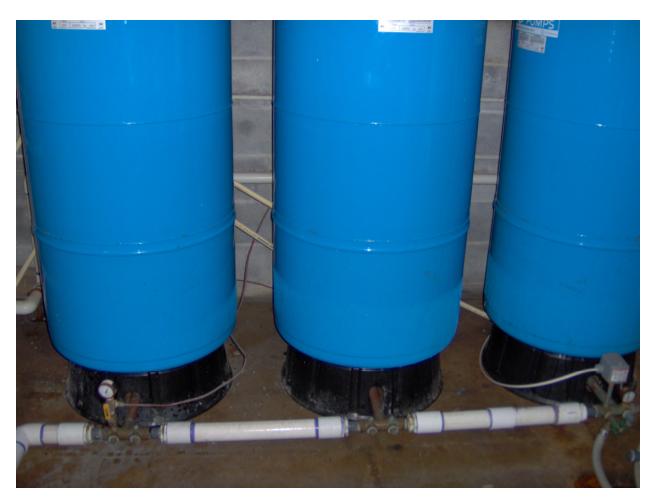
#### Use

- Volume
- Pressure

#### Size based upon

- Population served
- Peak demand
- Capacity of pumps used (source & distribution)
- Fire flow

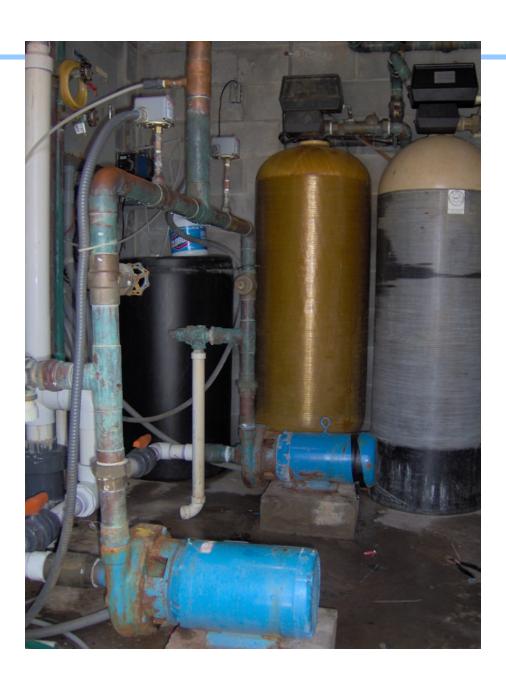
#### MDE DEFECT: PUMPS/ CONTROLS

- Inadequate booster pump capacity
- Inadequate maintenance
- Inoperable control system

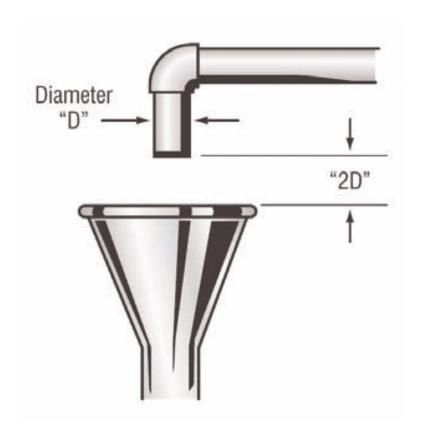
### **CROSS CXN DEVICE: AIR GAP**

- Air gap 2x pipe diameter
- Always at least 1 inch
- Most effective/ no fail
- Non mechanical
- Common
- Backwash line

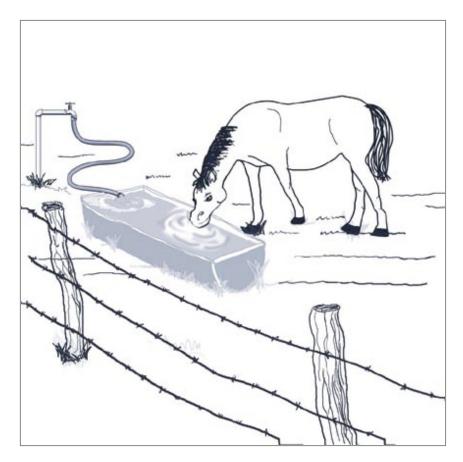
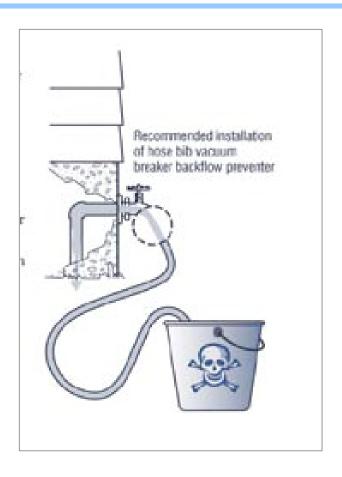
### **CROSS CXN DEVICE: AVB**

- Atmospheric vacuum breaker
- Simple, inexpensive
- For backsiphonage only
- Install 6" higher than outlet

Two situations for atmospheric vacuum breakers

"hose bib vacuum breakers"

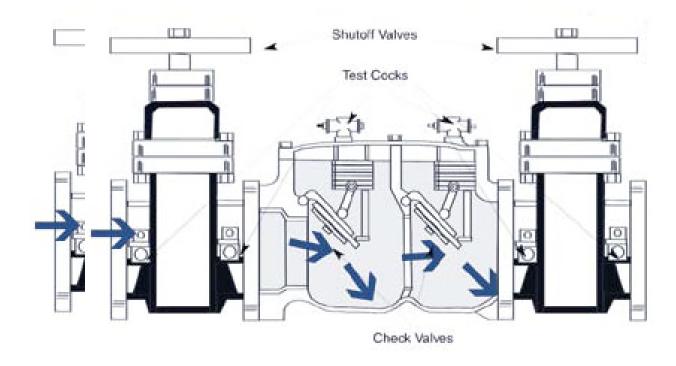
# MDECROSS CXN DEVICE: DOUBLE CHECK VALVE

- A single check valve can foul or break!
- Medium Hazard
  - Food processing
  - Residential water meters

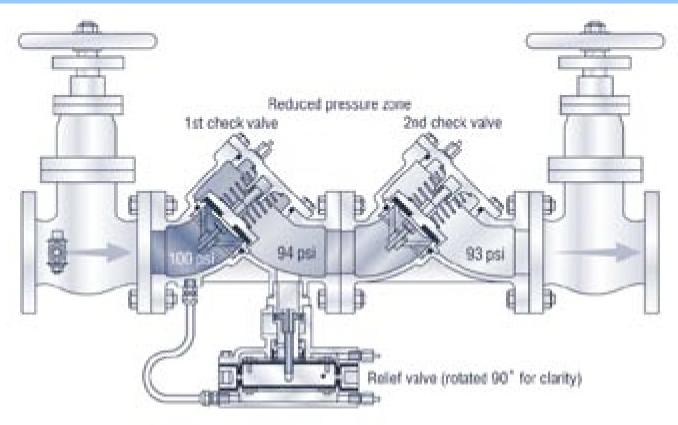
### **CROSS CXN DEVICE: RPZ/ RCBP**

# Reduced Pressure Zone Backflow Preventer

- Pressure relief valve vents to atmoshpere
- Maximum Protection for High Hazards
  - Industry
  - Car wash
  - High School Boilers
